RESERVE STUDY

Pheasant Run Association

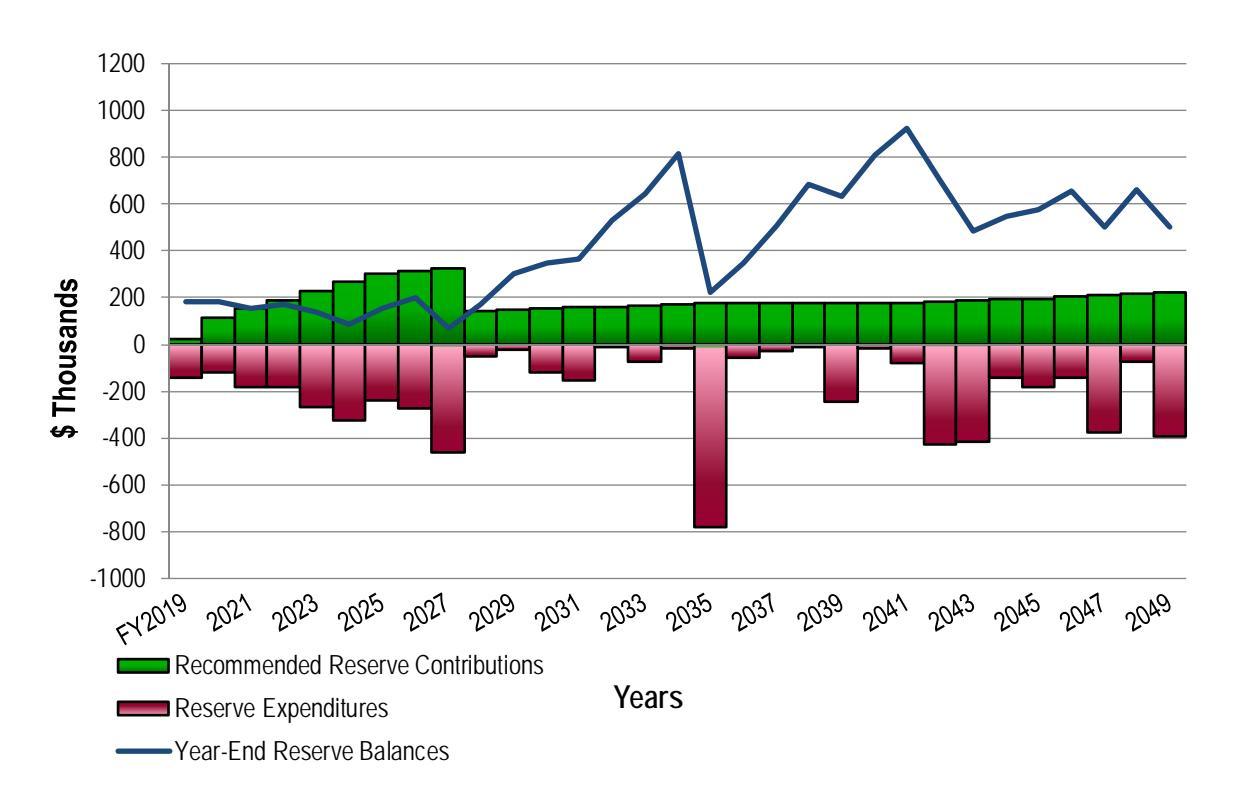
Pheasant Run Recommended Reserve Funding Table and Graph

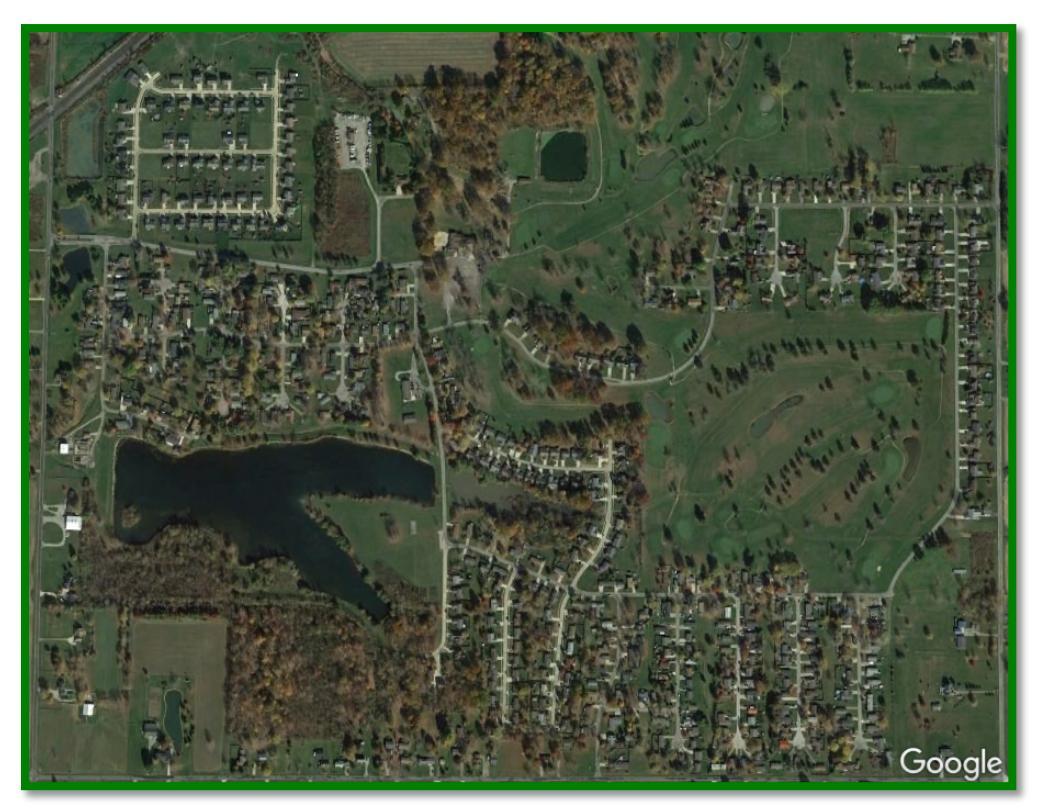
Our investigation includes Reserve Components or property elements as set forth in your Declaration. The Expenditure tables in Section 3 list the elements contained in this study. Our analysis begins by segregating the property elements into several areas of responsibility for repair and replacement.

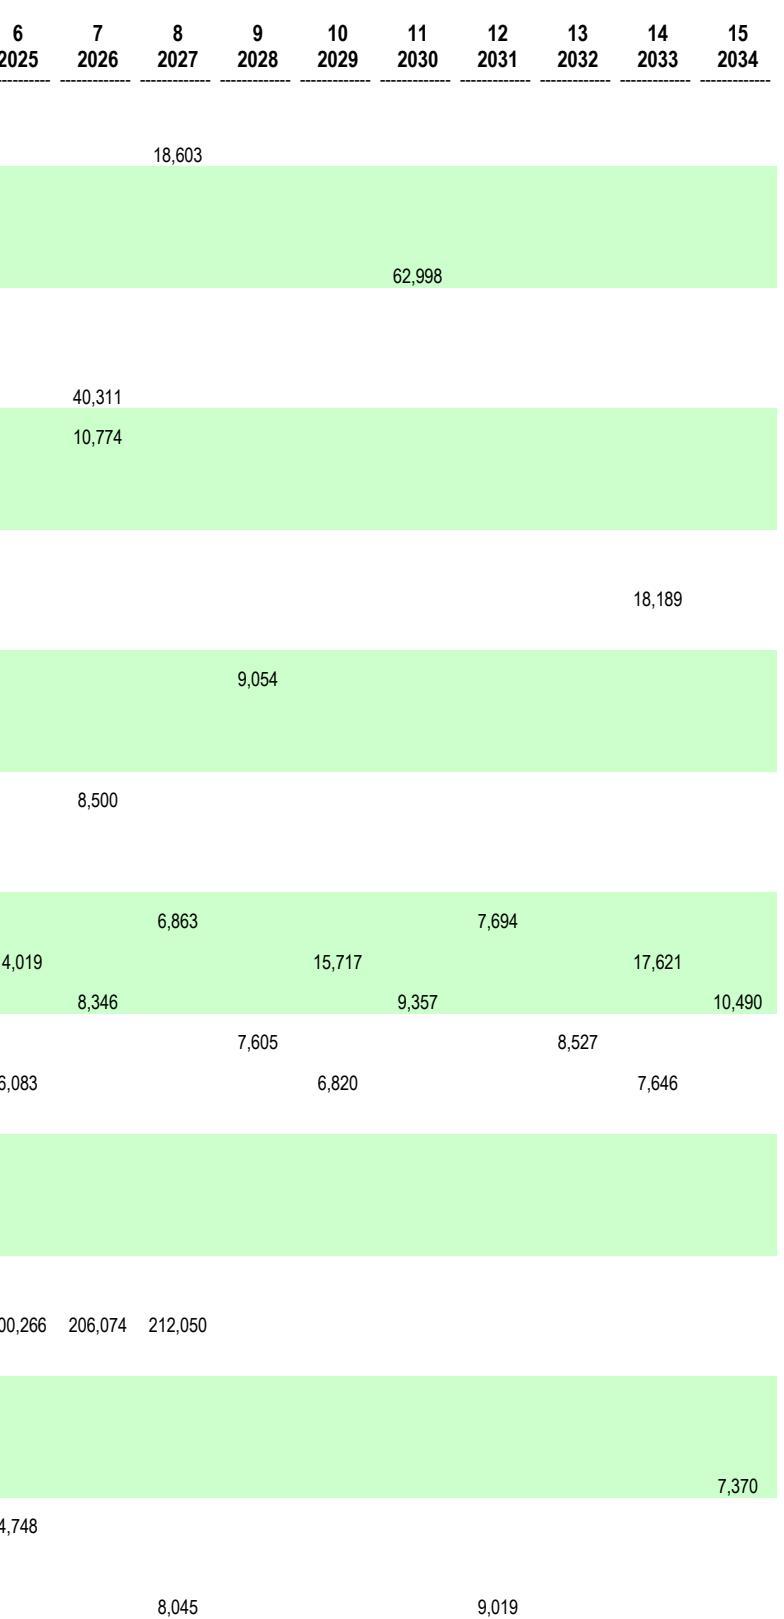
133,342 118,934 71,798

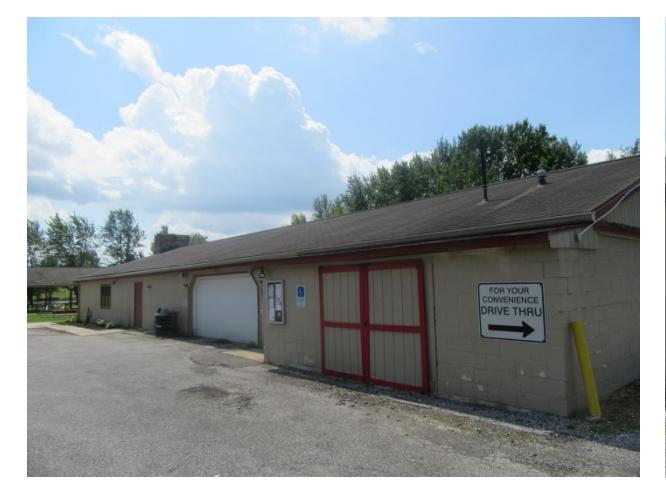
Office building front overview

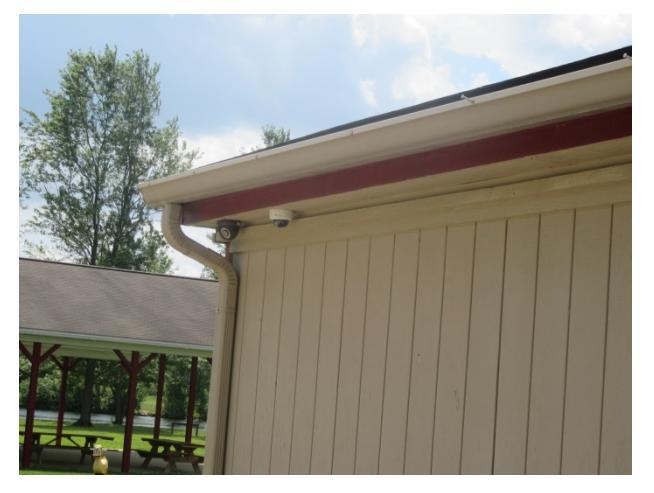
Gutter and downspout assembly

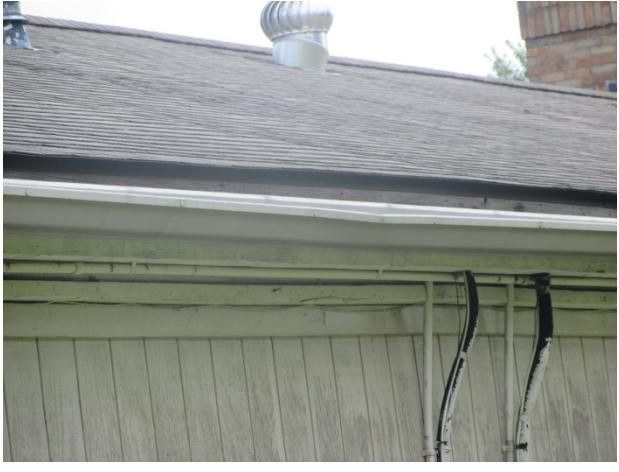
Minor gutter deterioration at the office building

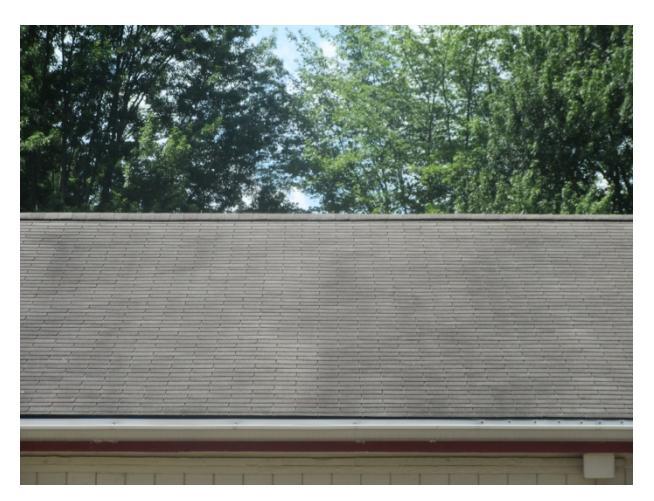
Maintenance building roof; we note shingle discoloration

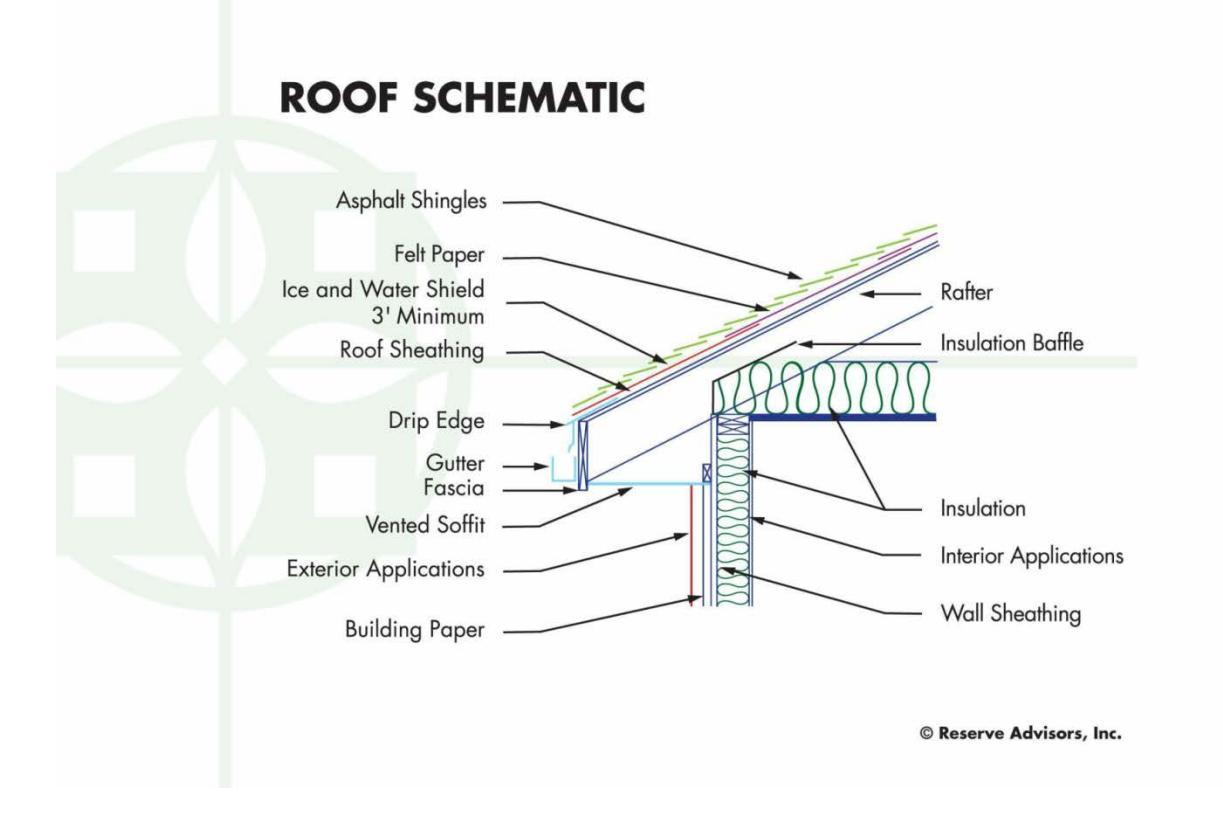
Contractors use one of two methods for replacement of sloped roofs, either an overlayment or a tear-off. Overlayment is the application of new shingles over an existing roof. However, there are many disadvantages to overlayment including hidden defects of the underlying roof system, absorption of more heat resulting in accelerated deterioration of the new and old shingles, and an uneven visual appearance. Therefore, we recommend only the tear-off method of replacement. The tear-off method of replacement includes removal of the existing shingles, flashings if required and underlayments.

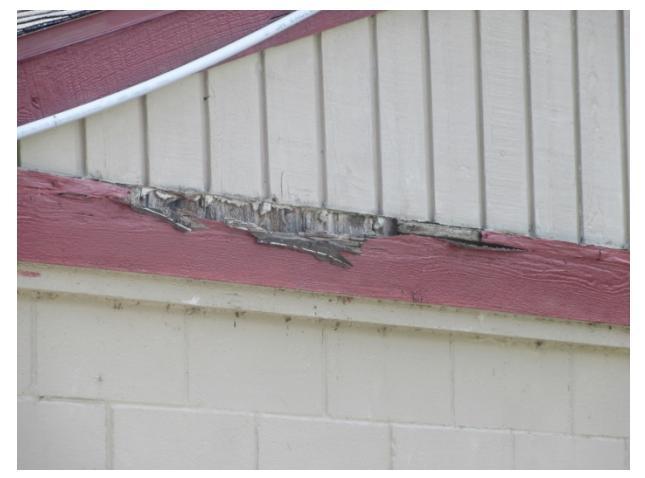
Trim deterioration at the office building

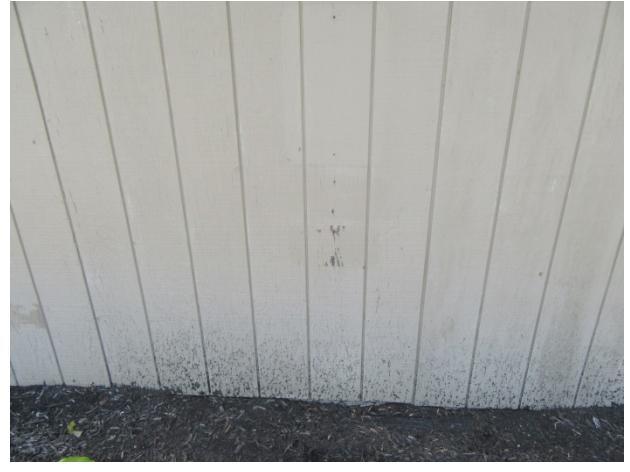
Plywood siding paint finish deterioration at the office building

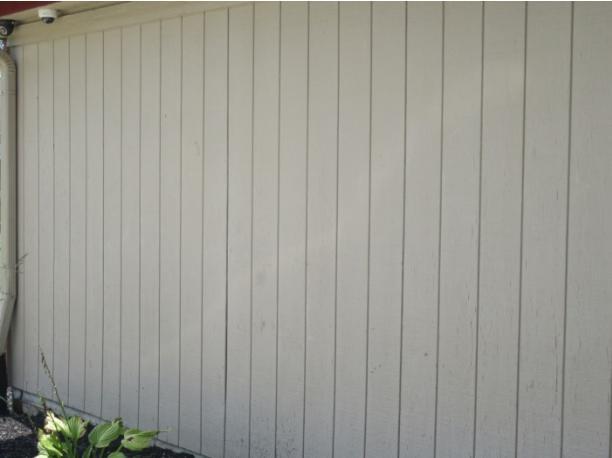
Trim and plywood siding finishes deterioration at the office building

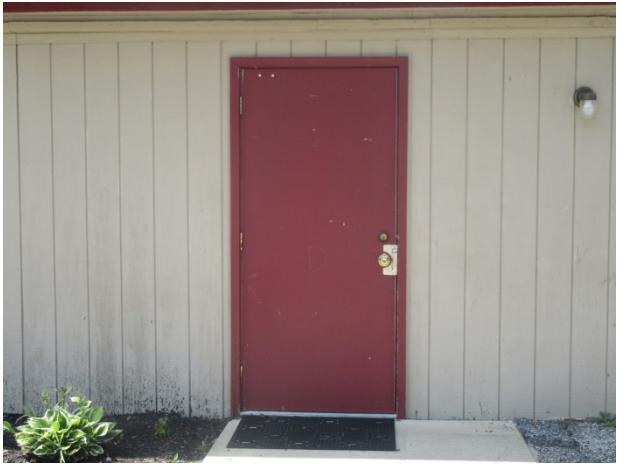
Condition: Fair overall with finish deterioration evident

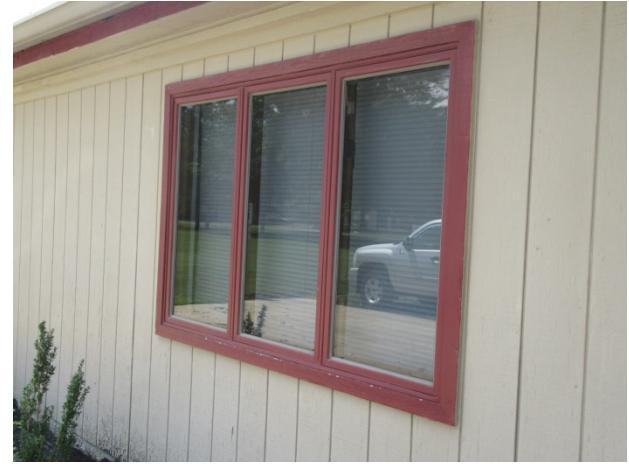
Door; we note finish deterioration

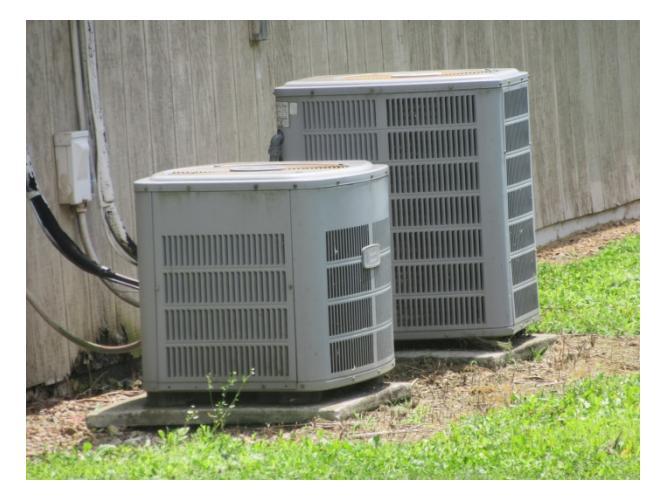
Office building condensing units

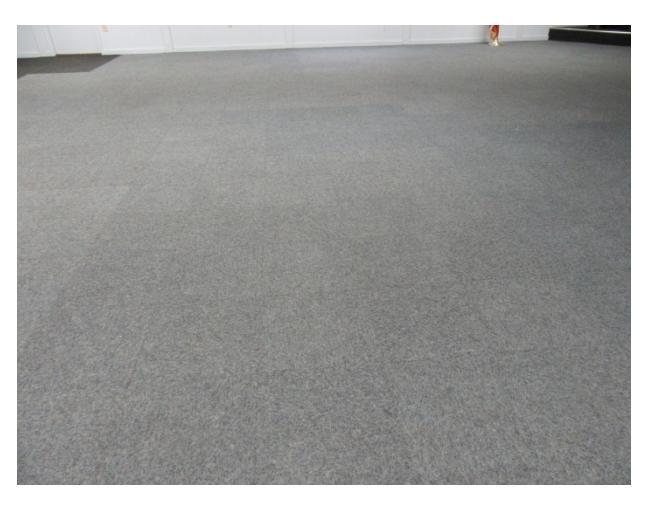
Carpet floor coverings; we note minor stains

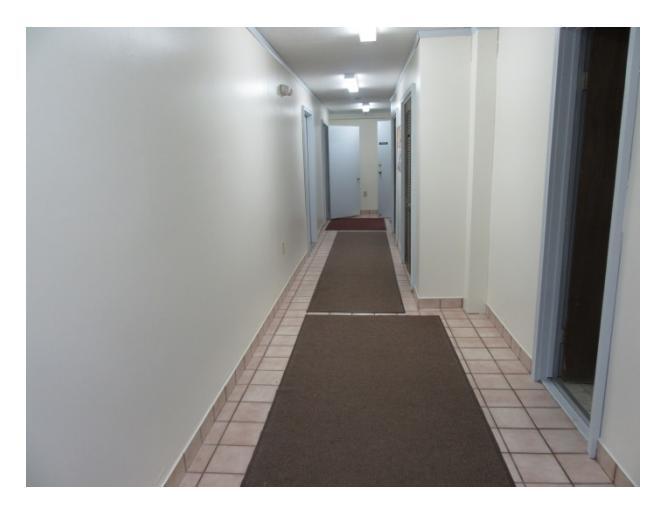
Ceramic tile at the office building hallway; we note isolated deterioration

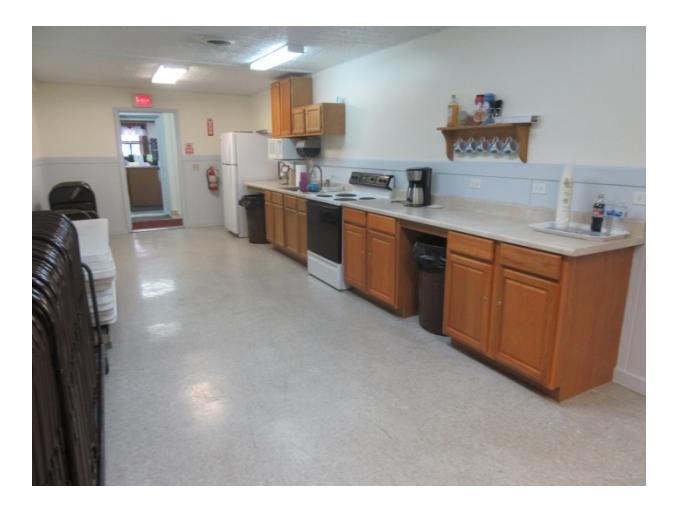
Office building kitchen

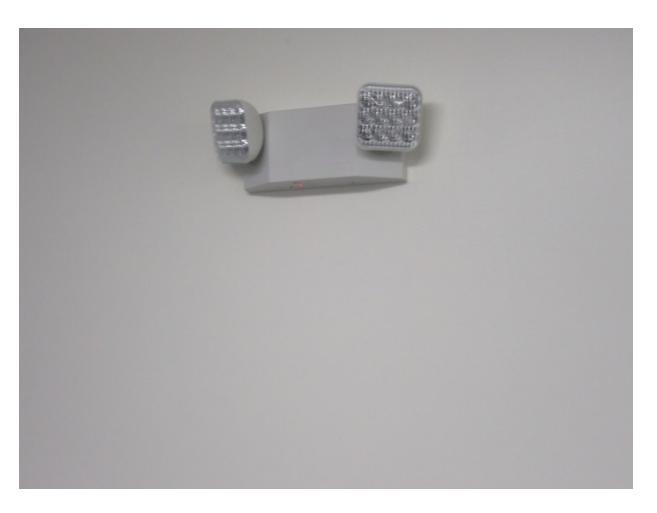
Emergency light fixture

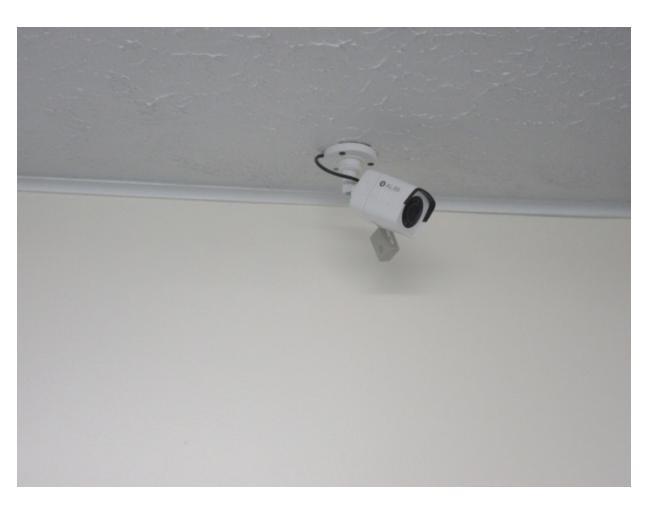
Office building security camera

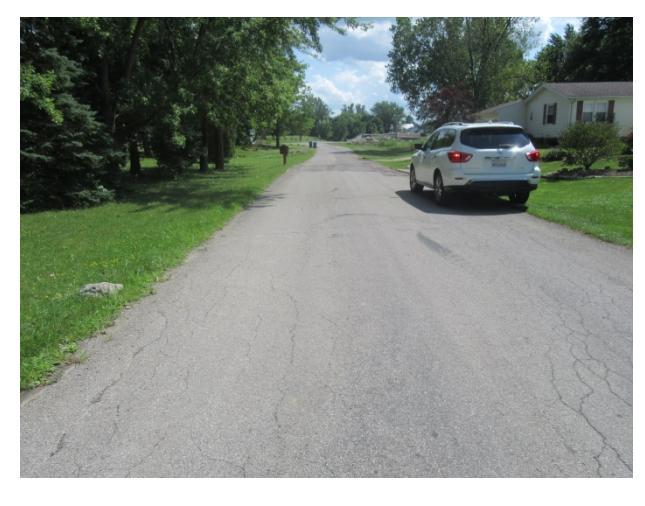
| Phase | Street Name | Quantity (Square Yards) | History | Condition |
|---|--|---|---|--|
| 5 | Parking lot, Sales Drive, Palomino, Ringneck, and Bobwhite Courts | 7,320 | Unknown year of last repair or repaving | Fair to poor overall with cracks and deterioration evident |

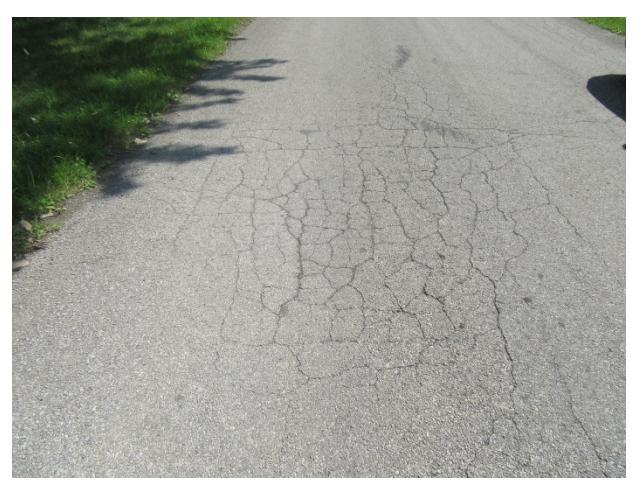
Phase 1 pavement, Sunset Drive; we note cracks

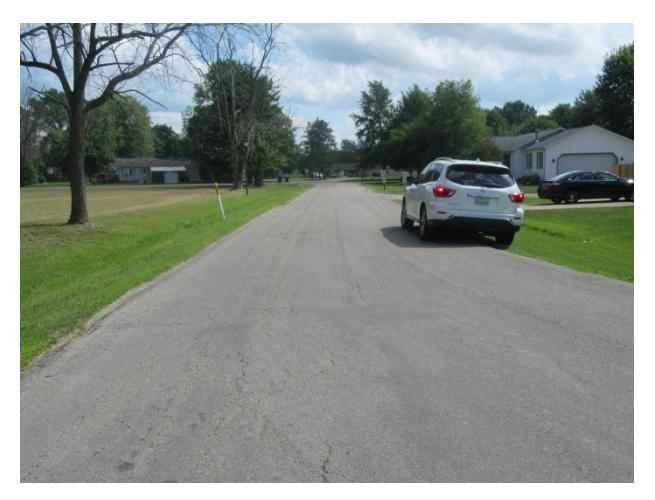
Phase 2 pavement, East Lake Drive; we note cracks

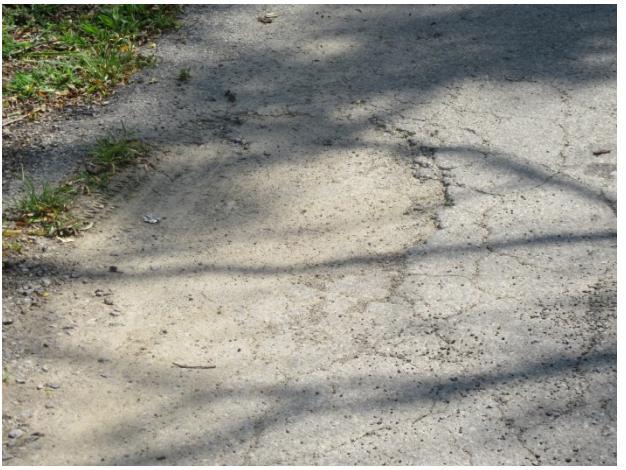
Phase 2 pavement, deterioration at Bass Court

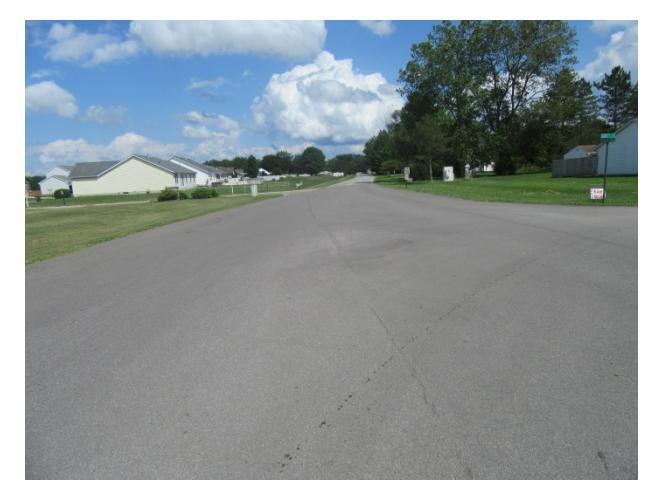
Phase 3 pavement, front entrance of the community

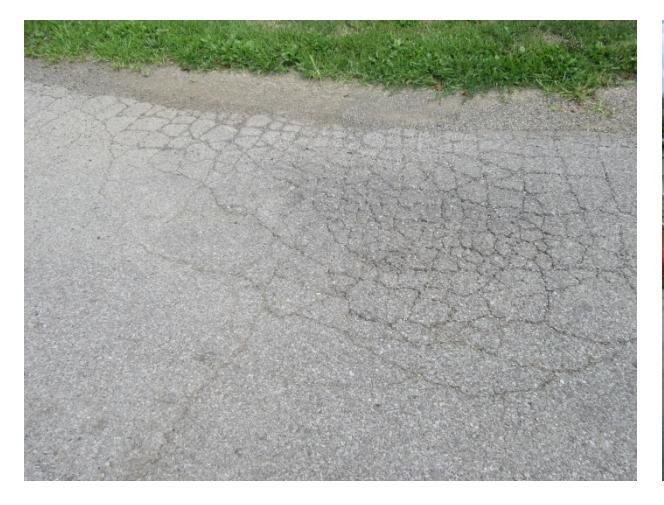
Phase 3 pavement, cracks at Hickory Run

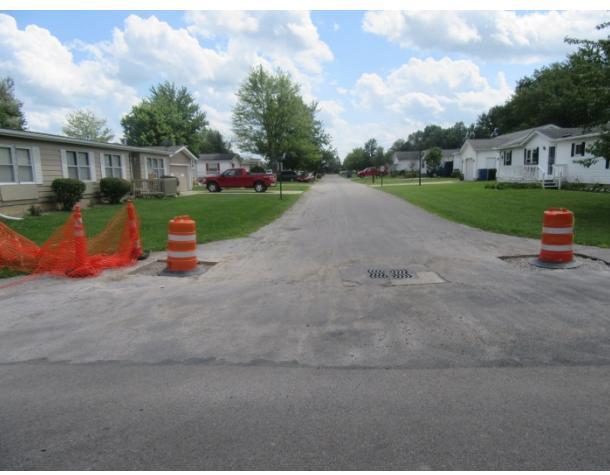
Phase 4 pavement, ongoing repairs at Stallion Court

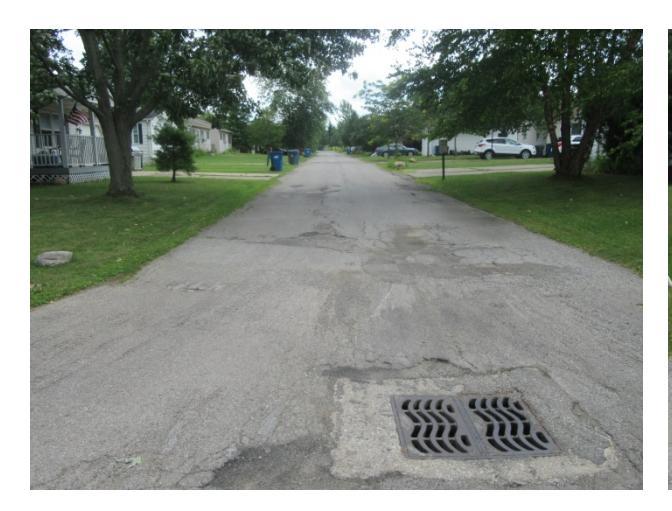
Phase 5 pavement, Palomino Court; we note cracks and deterioration

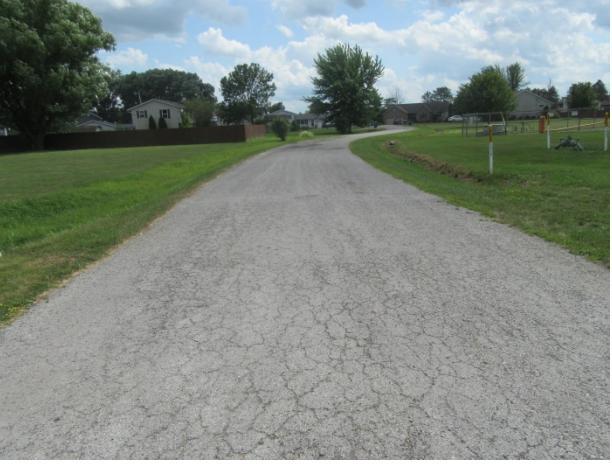
Phase 5 pavement, cracks and deterioration at Ringneck Court

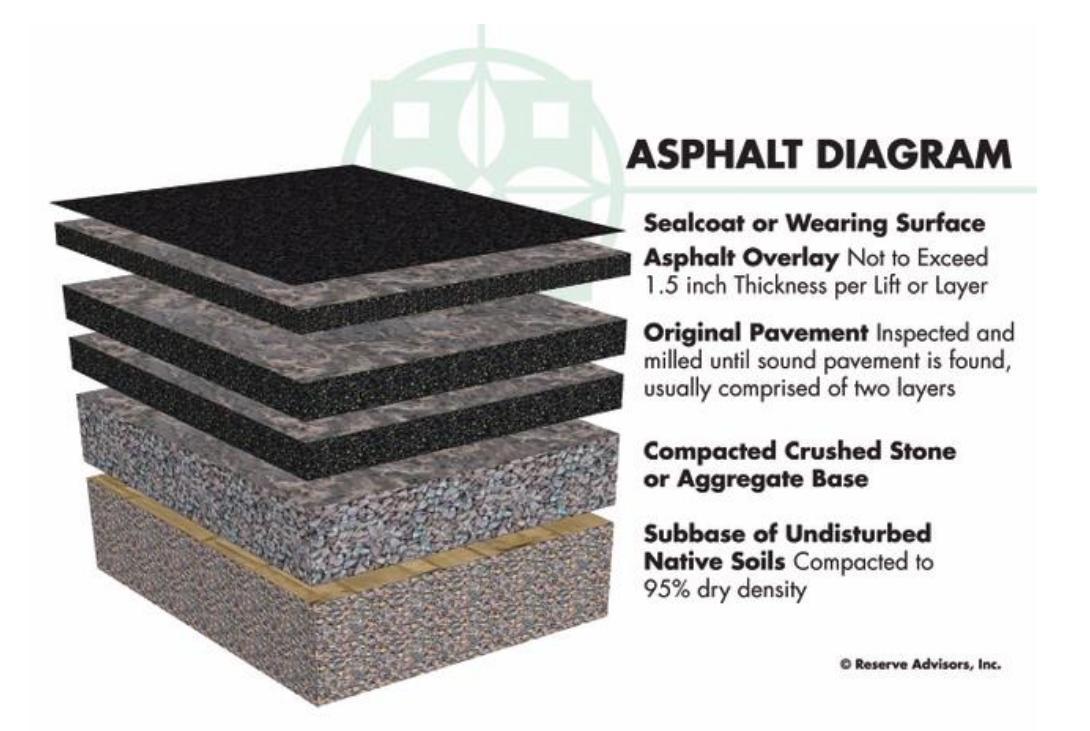
Component Detail Notes: The initial installation of asphalt uses at least two lifts, or two separate applications of asphalt, over the base course. The first lift is the binder course. The second lift is the wearing course. The wearing course comprises a finer aggregate for a smoother more watertight finish. The following diagram depicts the typical components although it may not reflect the actual configuration at Pheasant Run:

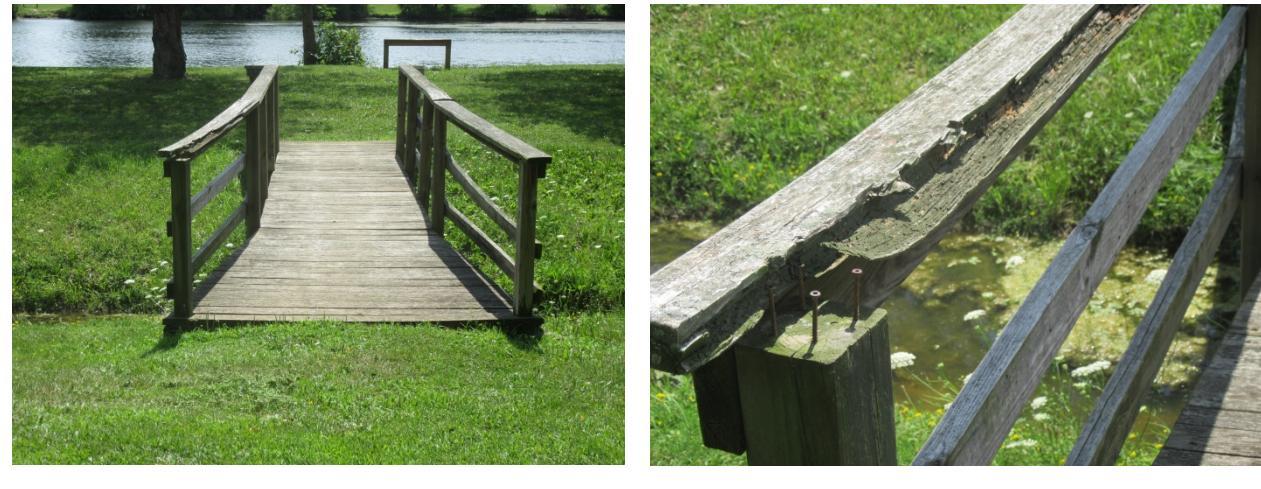
Condition: Fair overall with loose fasteners, deck board and railing deterioration evident

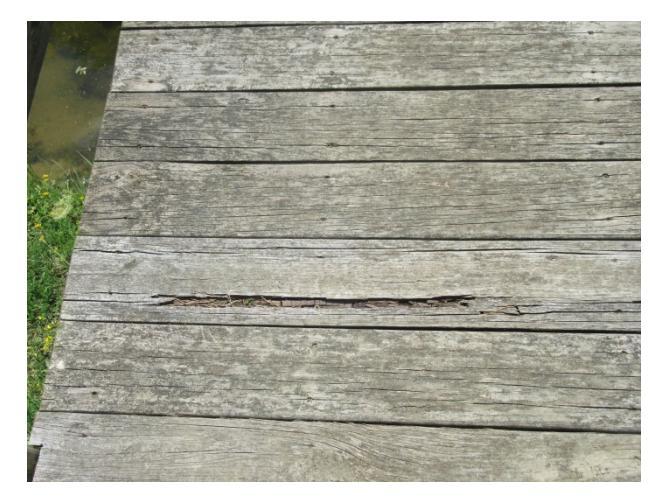
Wood bridge deck board deterioration

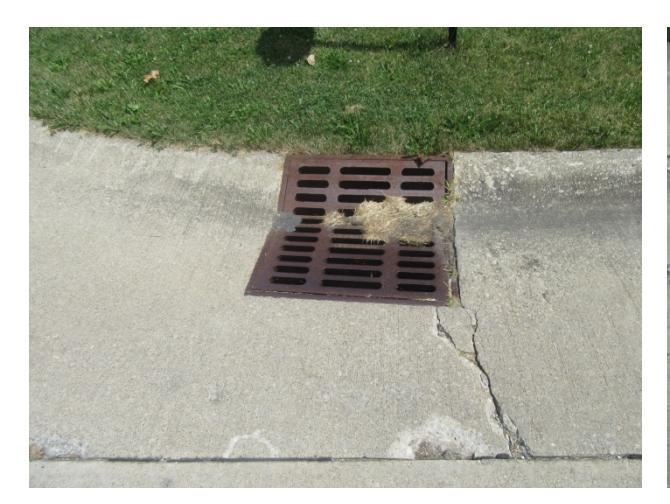
Catch basin collar crack at Horseshoe Drive

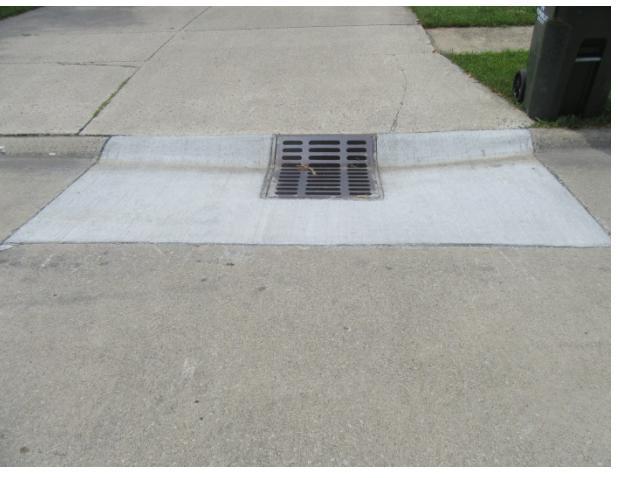
Catch basin replacement at Horseshoe Drive

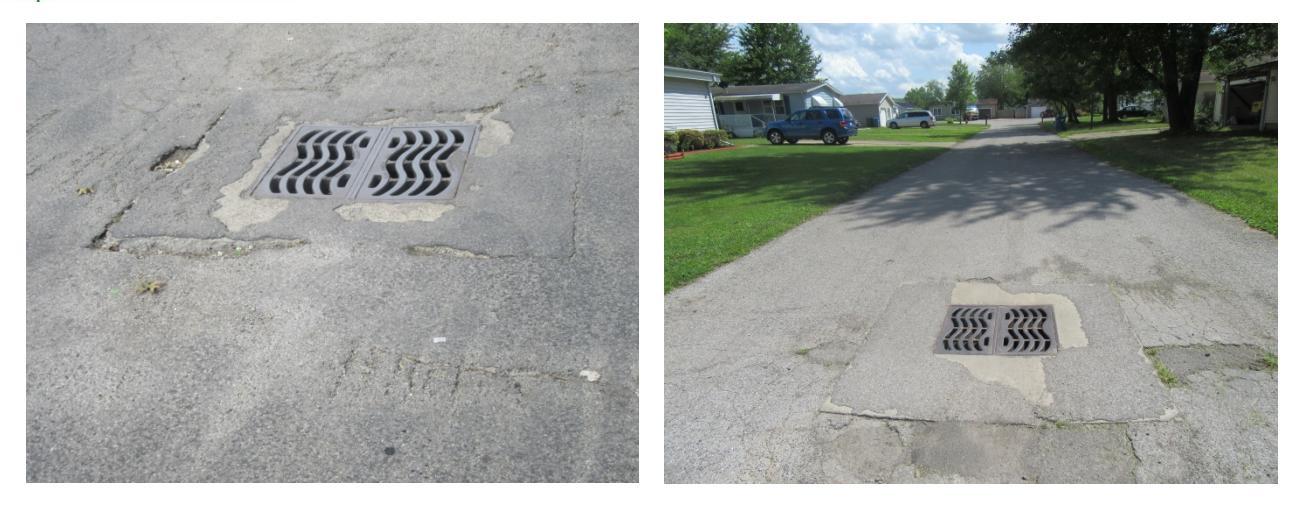
Catch basin deterioration at Morgan Court

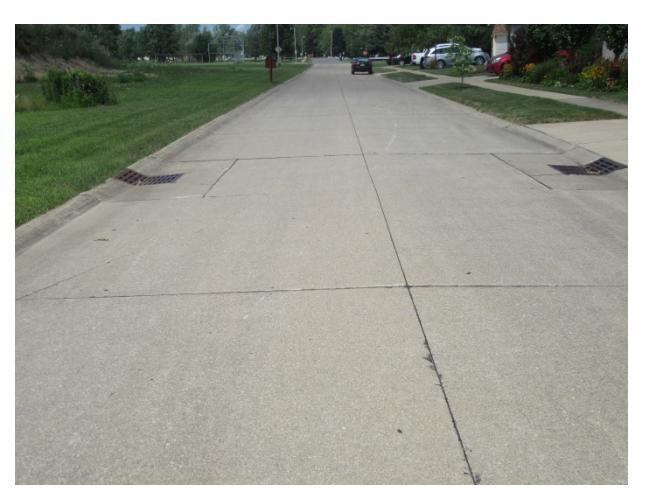
| Street name | Condition | |
|---|---|--|
| Blackbear Run | Good | |

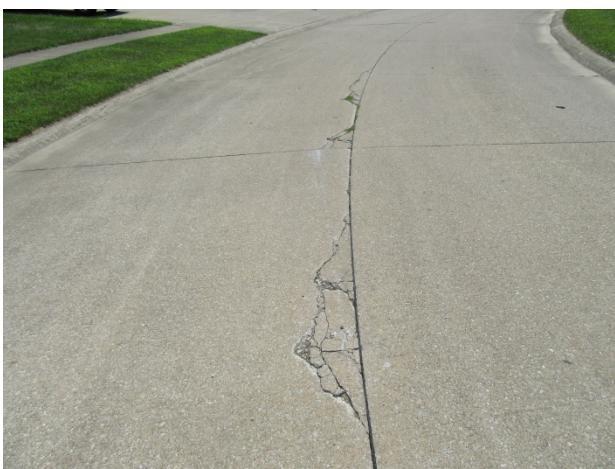
Concrete street, East Lake Drive

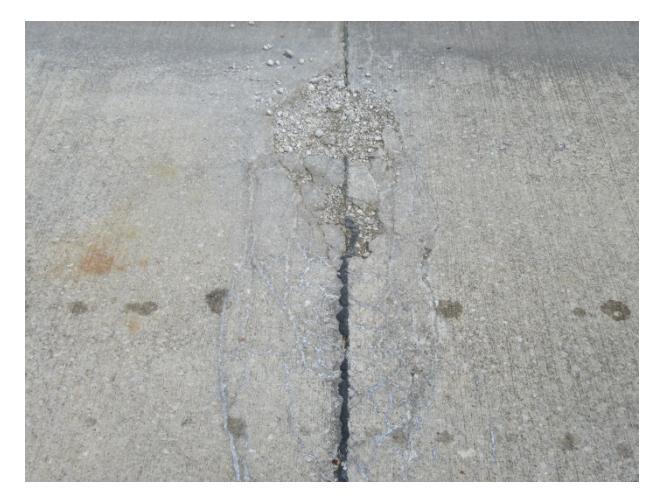
Concrete street deterioration at Horseshoe Drive

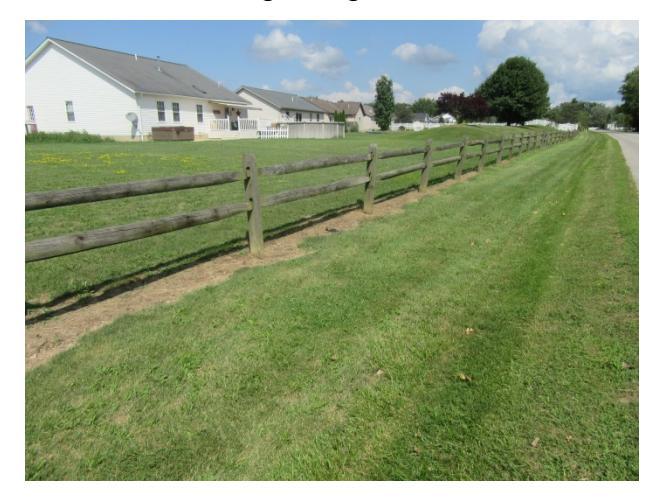
Wood split rail fence; we note organic growth and leaning sections

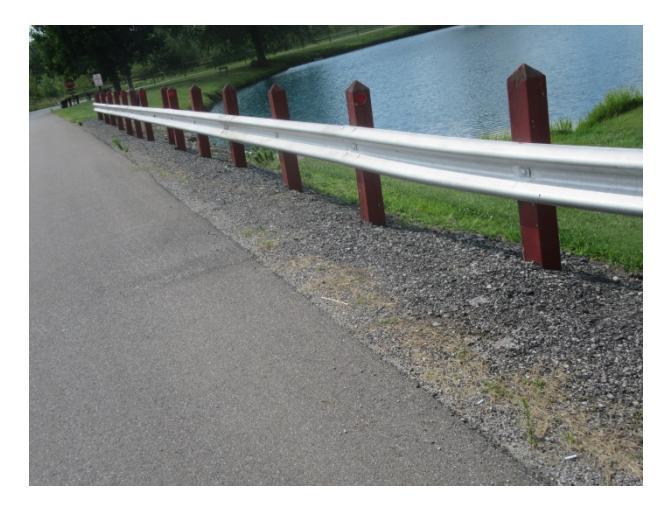
Condition: Good overall

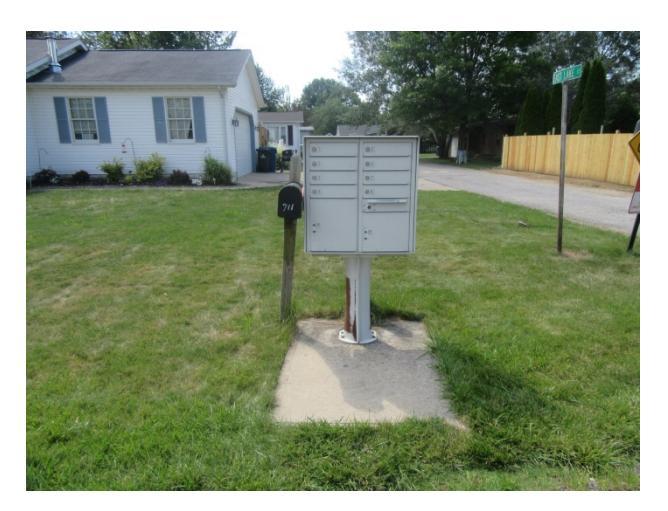
Mailbox station; we note finish deterioration

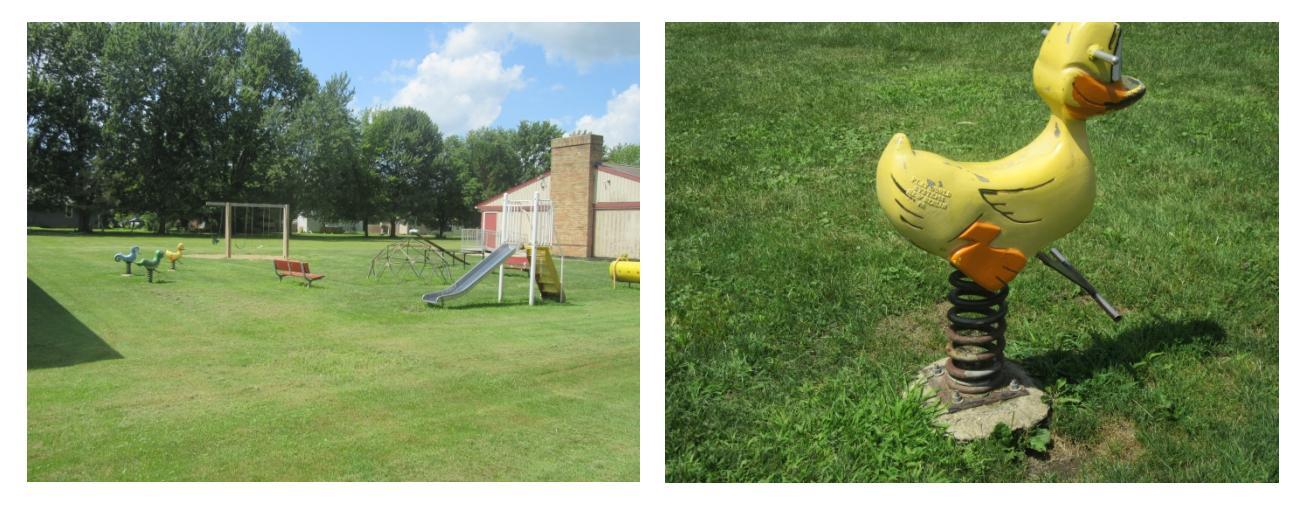
Playground equipment

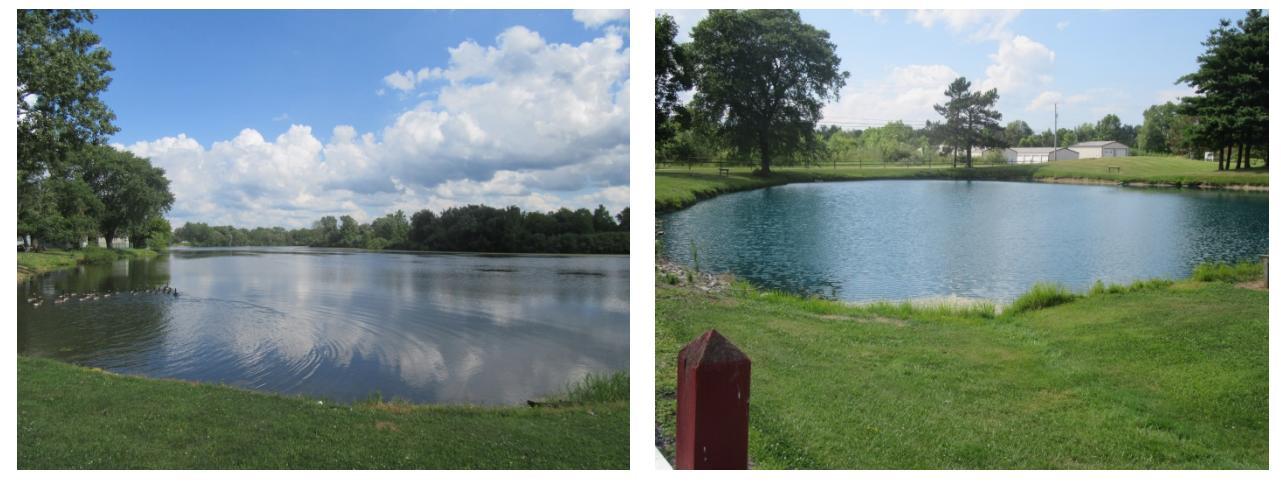
Condition: Fair overall with shoreline soil erosion evident

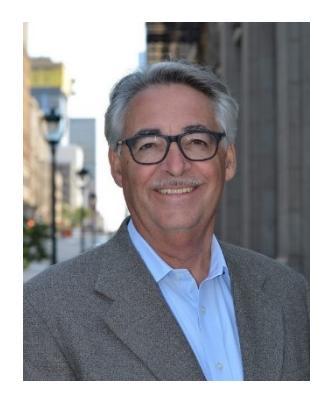
PRIOR RELEVANT EXPERIENCE

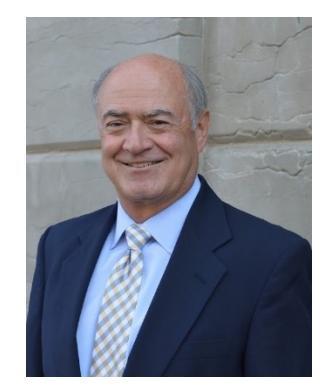
PRIOR RELEVANT EXPERIENCE
